Technical Note N-921

CORROSION OF MATERIALS IN HYDROSPACE

PART III - TITANIUM AND TITANIUM ALLOYS

NAVAL CIVIL ENGINEERING LABORATORY
Port Hueneme, California

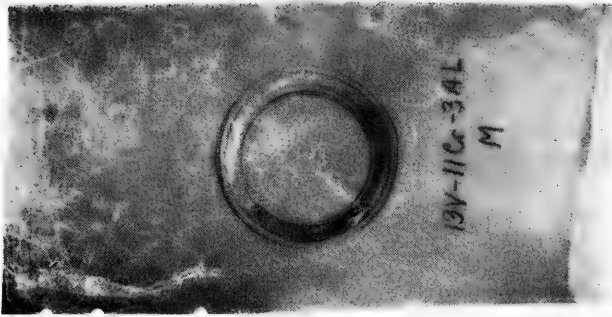
Figure 3. Circular weld (3" diameter) in 6" x 12" specimen, unrelieved.

Alloys 75A, Ti-0.15Pd, 5Al-2.5Sn, 7Al-2Cb-1Ta, 6Al-4V and 13V-11Cr-3Al were exposed with an unrelieved 3-inch diameter circular weld bead in the center of 6" x 12" specimens as shown in Figure 3. Only the 13V-11Cr-3Al alloy failed by stress corrosion cracking because of the residual welding stresses. Cracking occurred during surface exposure of 181 days, during 403 days of exposure at a depth of 6,780 feet, during 751 days of exposure at a depth of 5,640 feet, and during 402 days of exposure at a depth of 2,370 feet. The cracks in all cases were radial across the weld beads, a typical crack is shown in Figure 7. The crack in this case changed direction by 90 degrees (left side of Figure) just outside the weld bead because of the redistribution of the residual stresses.

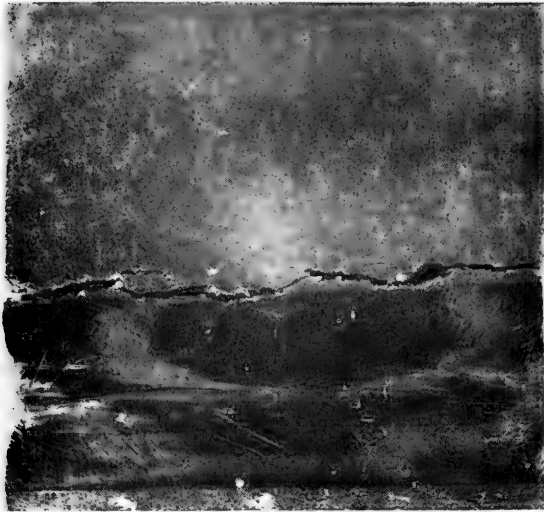
Figure 5. Stress corrosion crack across specimen of 13V-11Cr-3Al alloy at the edge of the weld bead. Note secondary branching cracks extending from main fracture.

failed by stress corrosion cracking when stressed at values equivalent to 75 percent (94,500 psi) of its yield strength after 35, 77 and 105 days of exposure at the surface in the Pacific Ocean. The stress corrosion cracks occurred at the edge of the weld bead as shown in Figure 5.

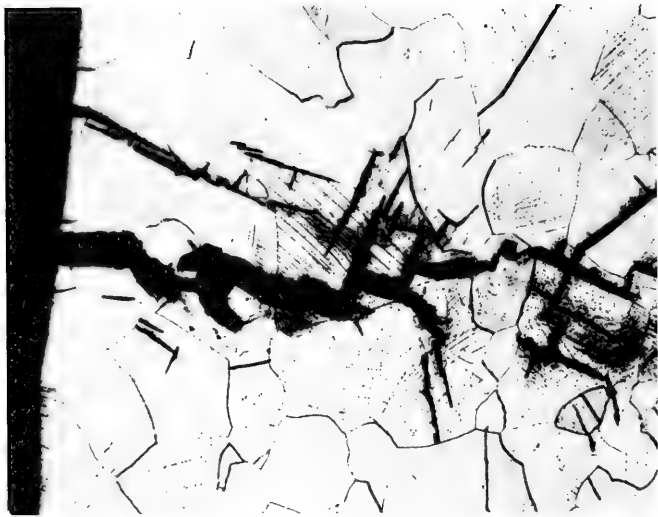
Figure 6. Secondary crack in parent metal away from and parallel to main fracture. Crack is branching in nature and transgranular. Etched in lactic, hydrofluoric and nitric acid mixture. X100.

Metallographic examinations of unetched and etched sections in a plane parallel to the surface of the specimen showed that a secondary crack which started at the edge of the specimen in the parent metal away from and parallel to the main fracture was irregular and branching in nature as well as transgranular as shown in Figure 6. This is typical of the main fracture.

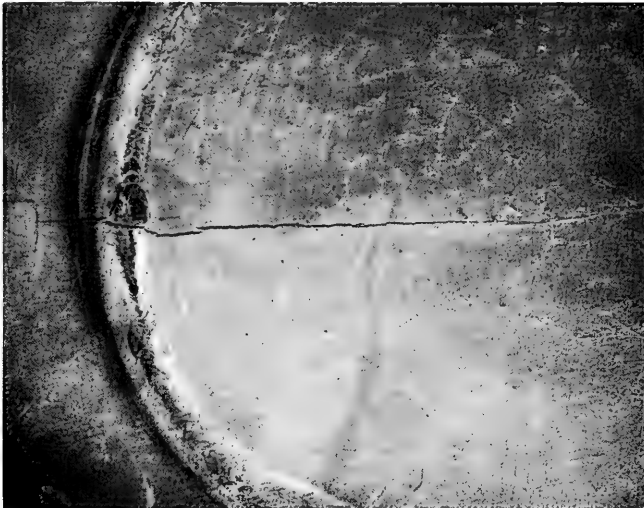
Figure 7. Radial stress corrosion crack across weld bead of 13V-11Cr-3Al.

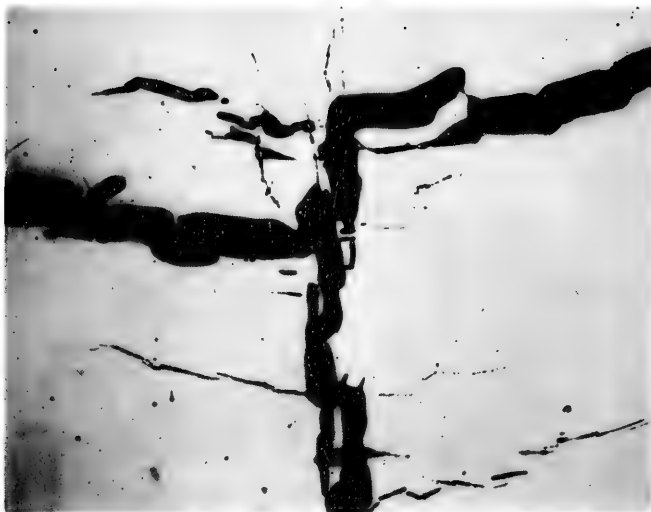
Figure 8. Irregular, branching stress corrosion crack in 13V-11Cr-3Al. Unetched. X100.

Metallographic examination of a polished section of the crack taken in the plane of the sheet where it changed direction showed that the path of the crack was irregular and branching in nature as shown in Figure 8. After etching and reexamination it was found that the crack was predominantly transgranular as shown in Figure 9.
